Selected Systems Engineering Process Deficiencies & Their Consequences

**L. Dale Thomas, Ph.D., P.E.
National Aeronautics and Space Administration
George C. Marshall Space Flight Center**

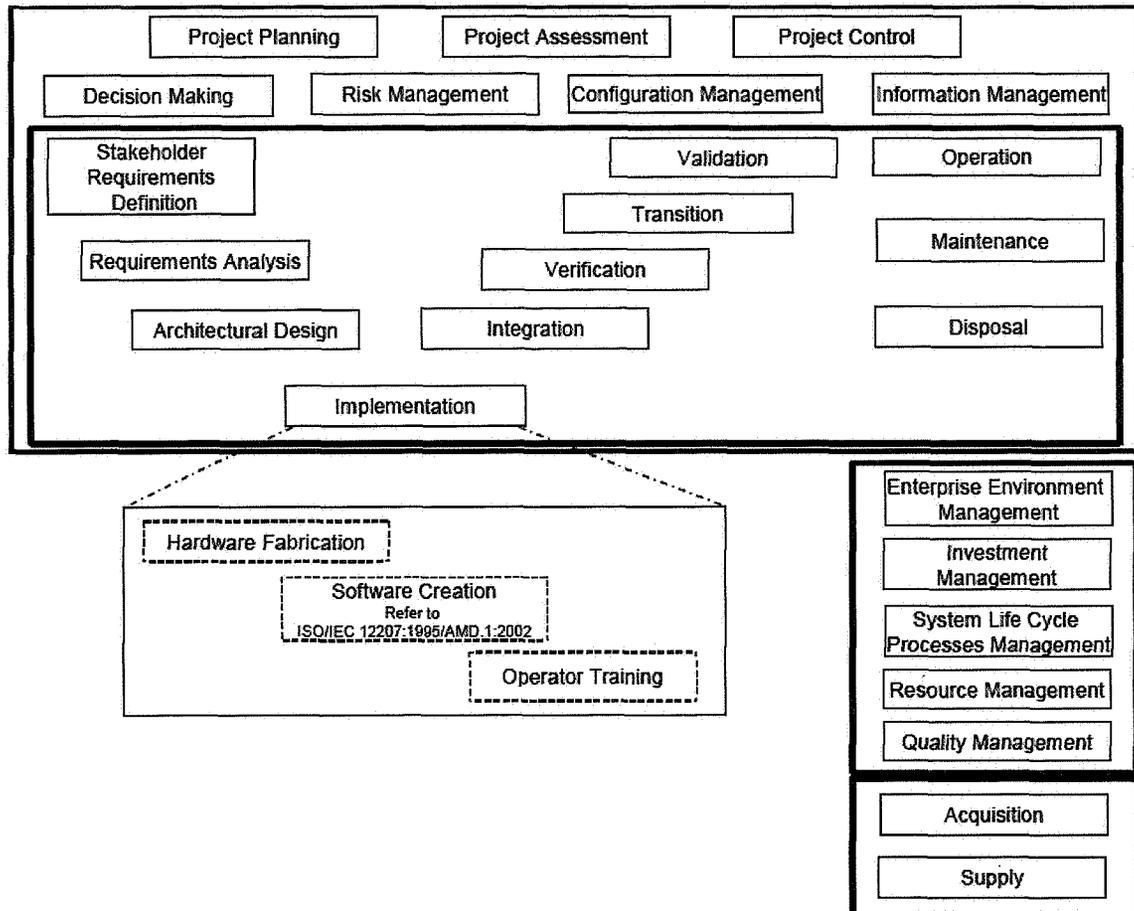
Figure 2. Systems Engineering Process Model (adapted from Figure C.1 in ISO/IEC 15288)

Figure 2 depicts the foregoing Project and Technical processes that provide the benchmark systems engineering process model which the system failures in the following section will be assessed.
